# *Burnt Clay Products in Fire and Earthquake*

*Issued by the Manufacturers of Burnt Clay Products*  
***Brick Construction Association***  
*707 Lankershim Building, Los Angeles, Cal.*

## *The San Francisco Calamity*

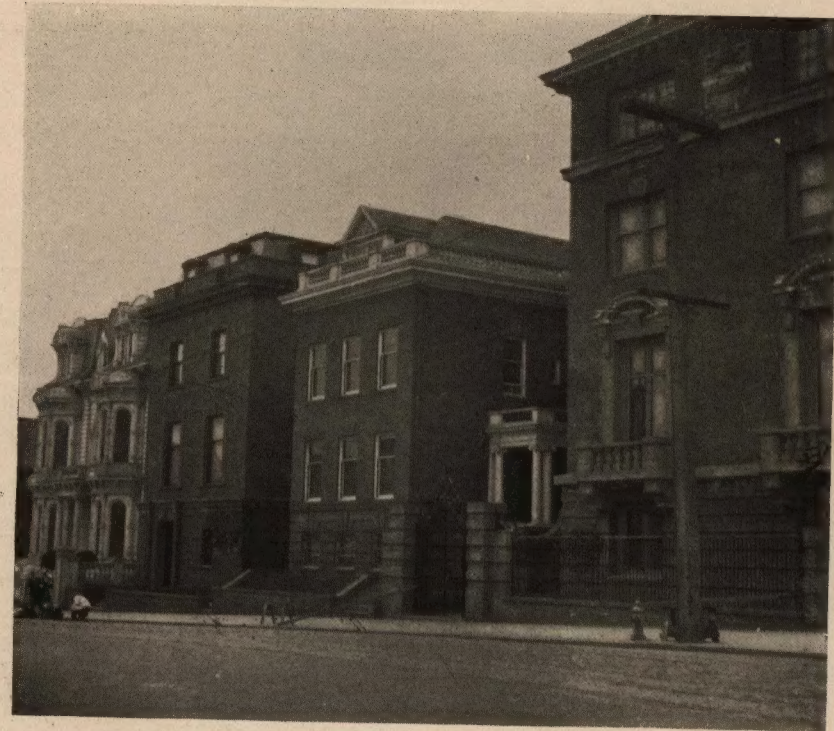
### *Good Brick Work*

Brick Residences, Pacific Avenue, San Francisco.

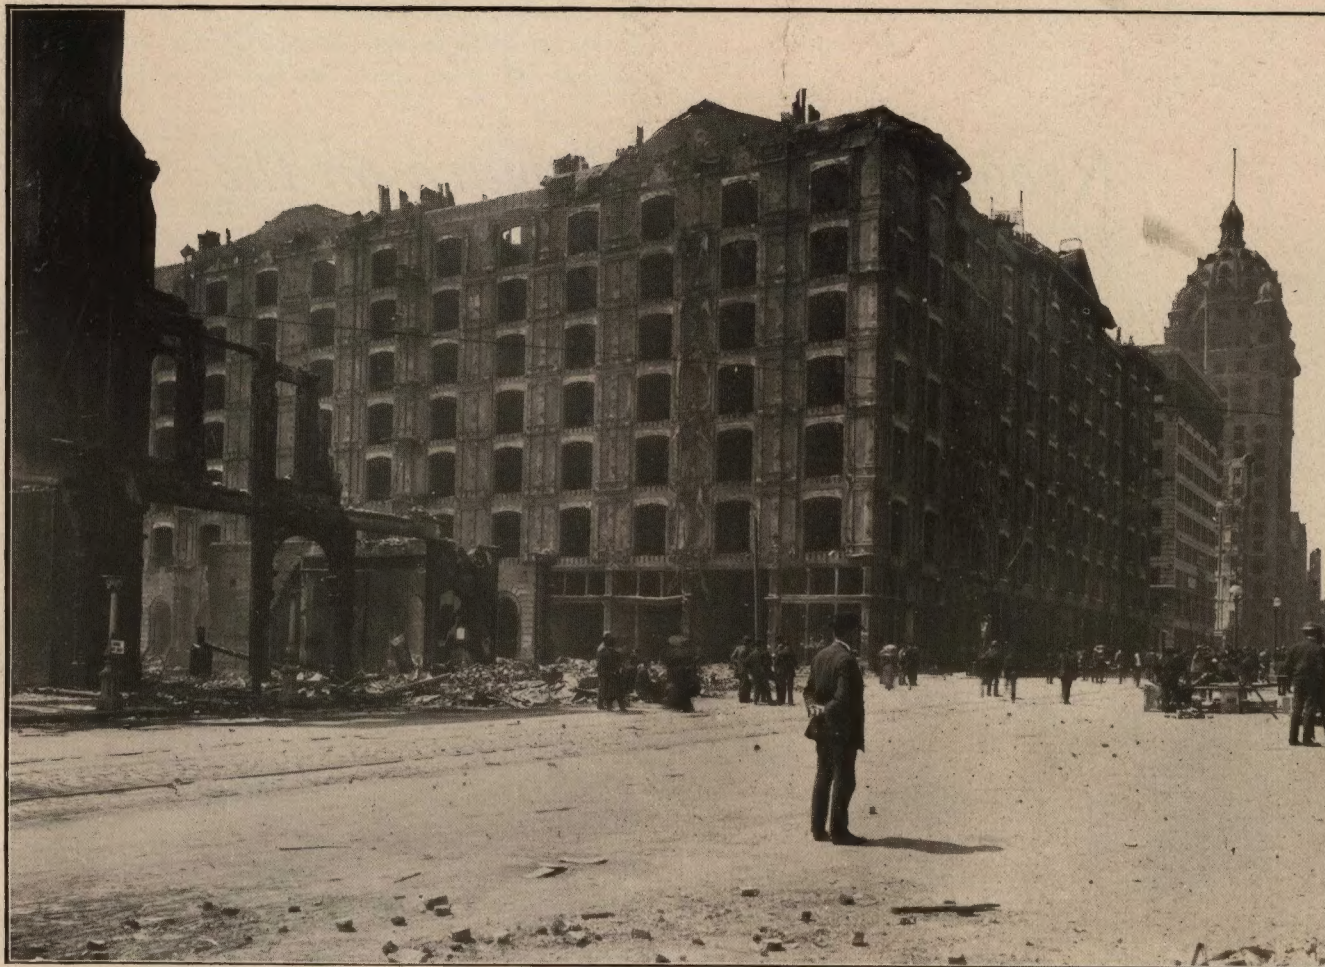
### *Palace Hotel*

Showing Monadnock and Call buildings to the right.

This building was 150 feet high, of old-style true and tried brick construction throughout. Foundations, exterior and all interior walls were of brick; floors, windows and doors being of wood.

The building stood on filled ground, and there was no structure in San Francisco the walls of which stood a more severe test, from both earthquake and fire, than this. While it swayed and bent with the force of the earthquake, it regained its former position without a single crack from the vibrations.

Fire a few hours later destroyed the interior, leaving the walls standing in perfect condition, a monument to GOOD brick work.

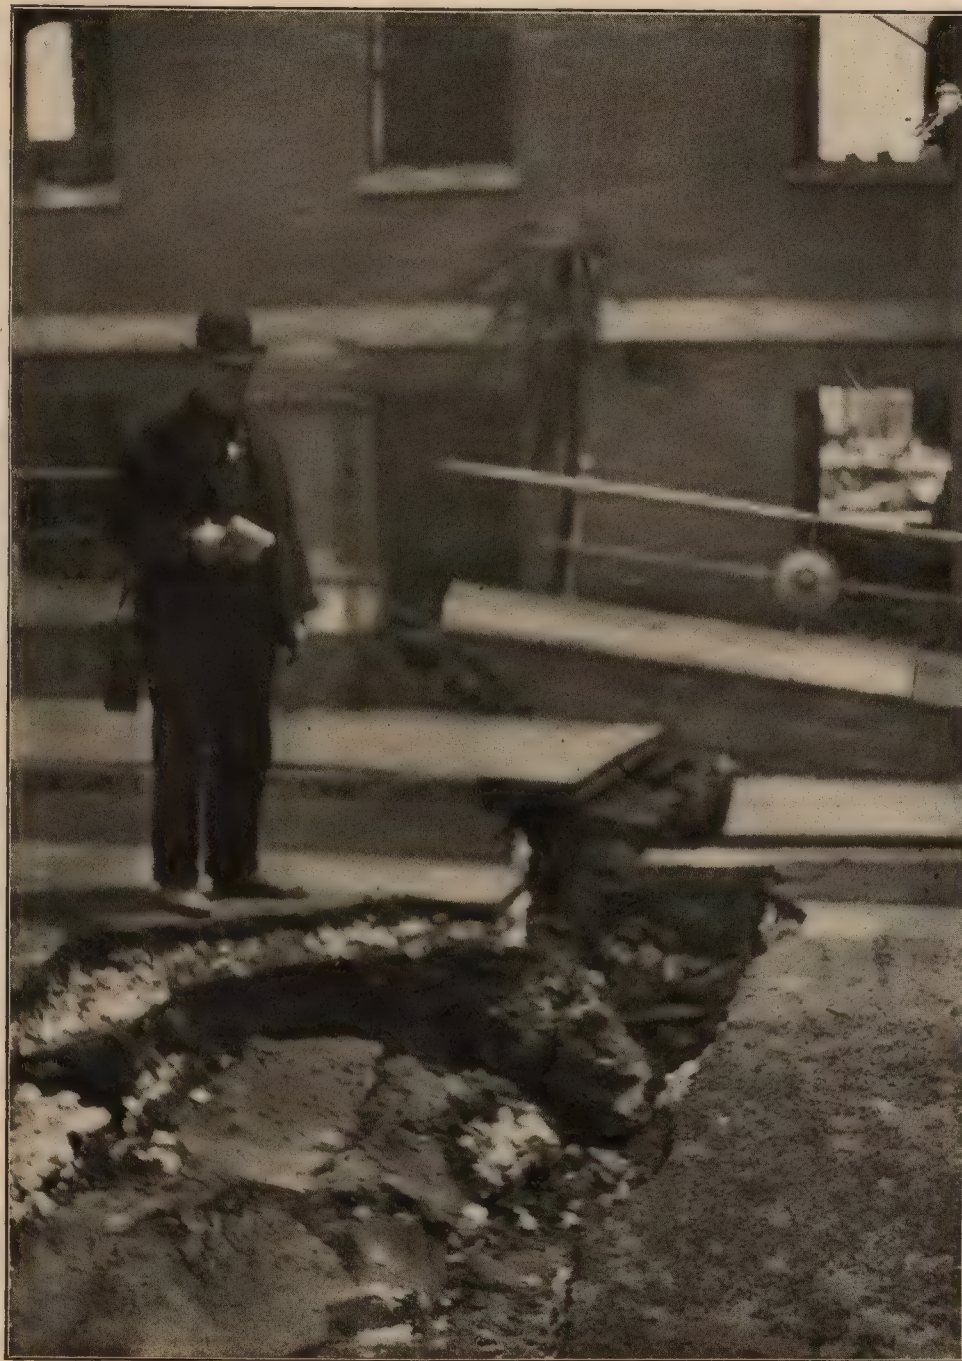
### *A Remarkable Incident*

This three-story brick building was in the Mission district, and was erected on filled ground.

The quake opened a crack in the ground passing entirely under the building, which, on account of the excellent brick-work, remained unharmed. Interior of the building was later destroyed by fire.

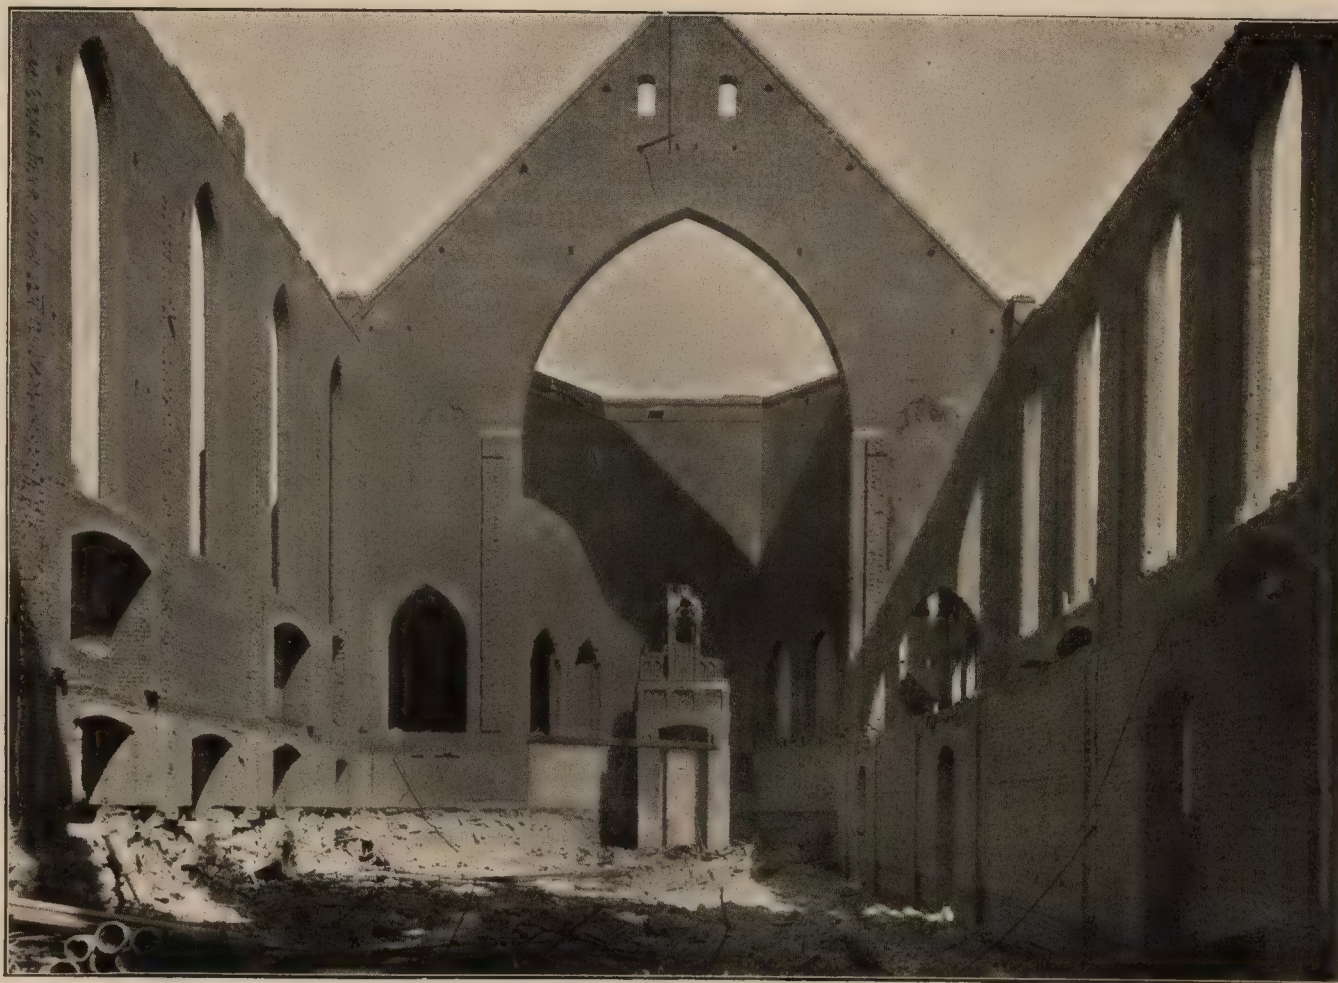
*St. Francis Church*

Brick. Erected in the fifties. Passed through two fires and earthquakes. Note perfect condition of brick walls, and compare with stone basement.

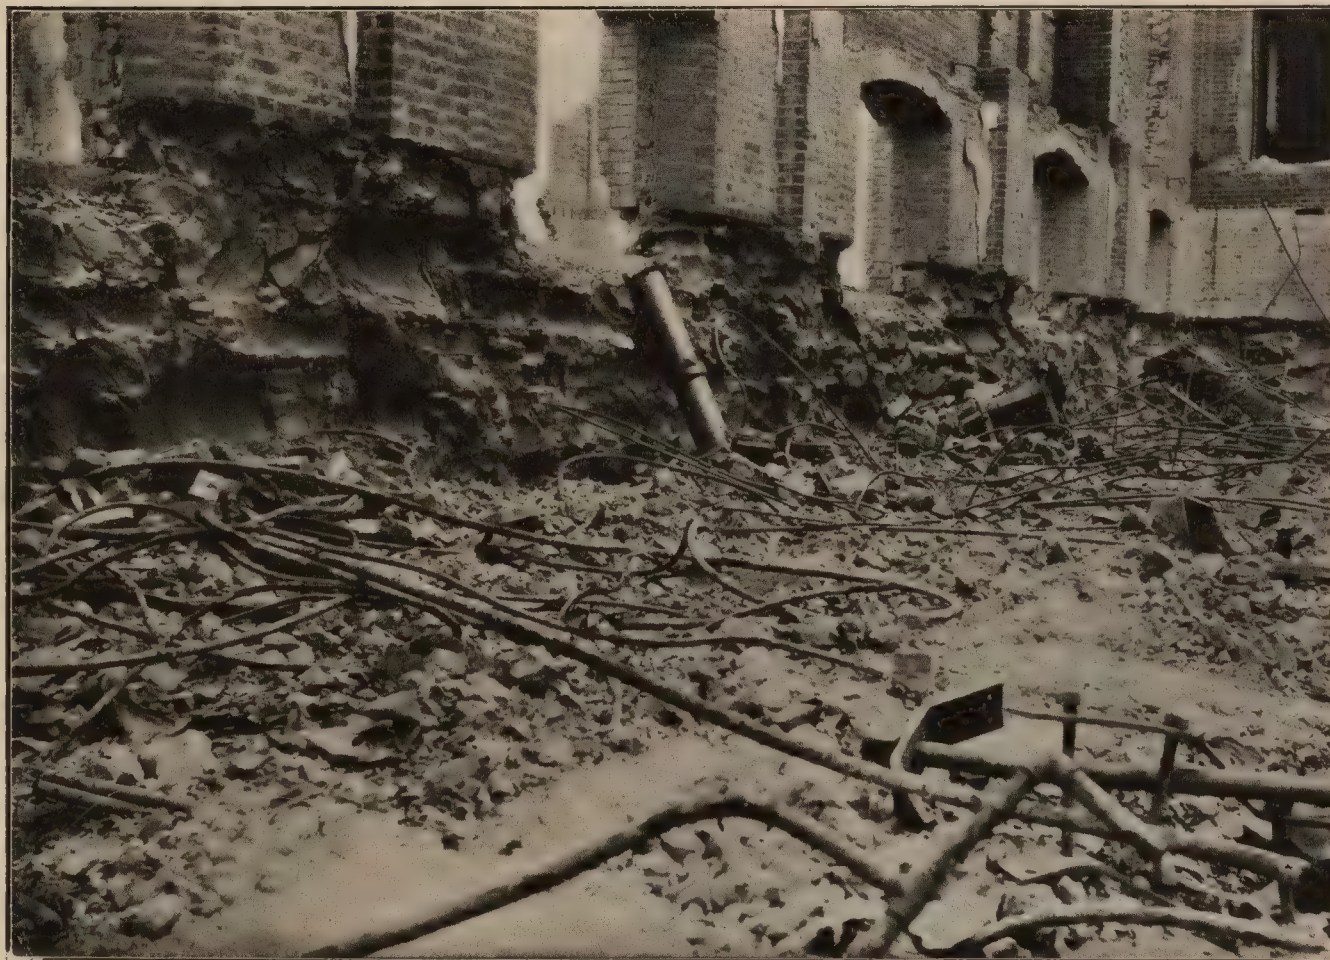
*Basement Walls of St. Francis Church*

Showing the effect of fire upon stone and brick.

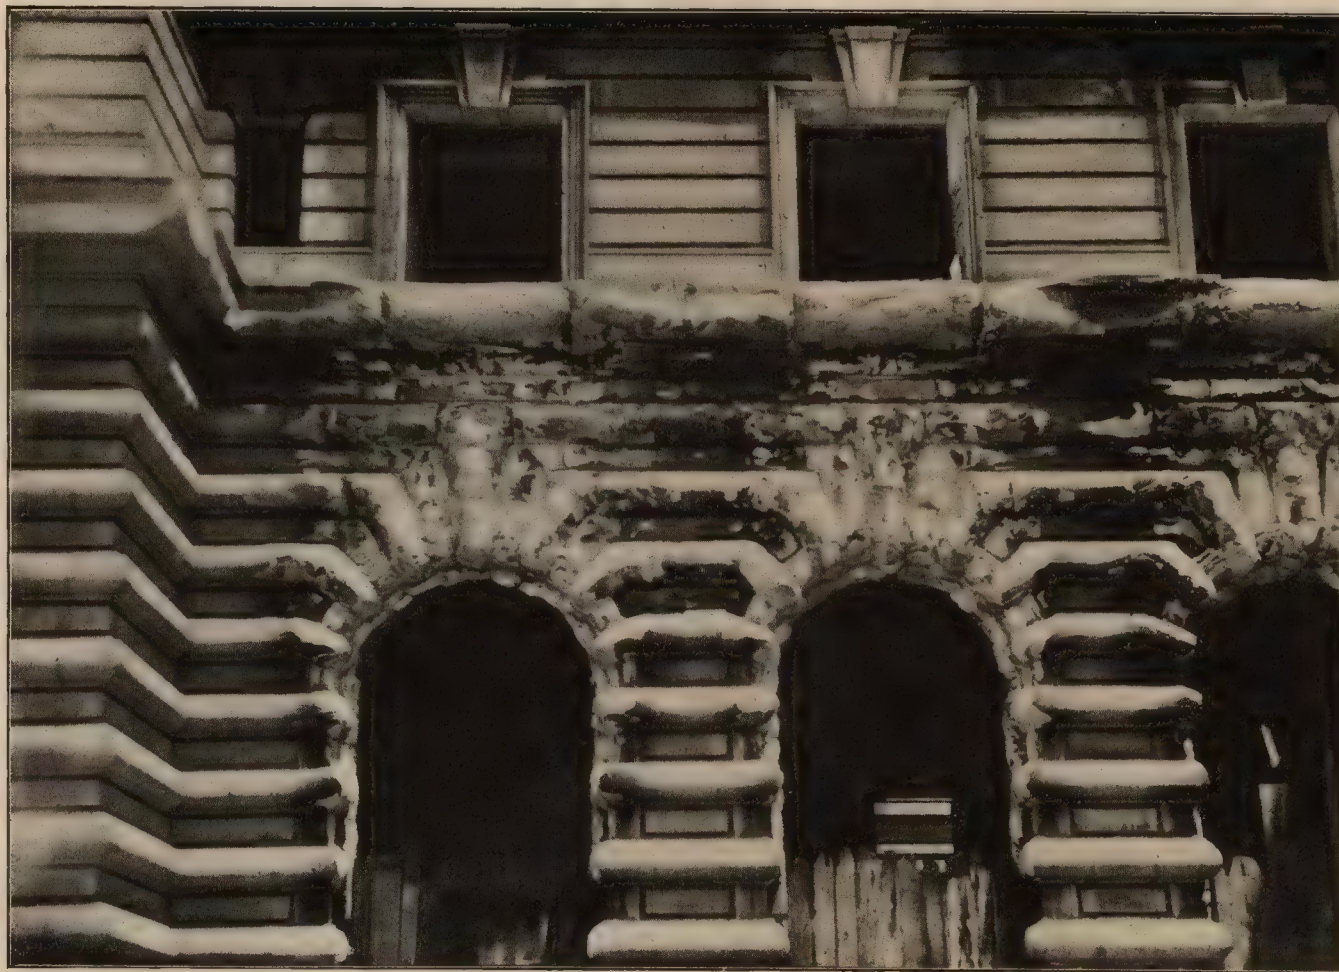
*Fairmont Hotel—Uncompleted when Damaged*

Showing by the unburned wood in window openings that only a low degree of heat is necessary to destroy granite. Note perfect condition of terra cotta on the second story, above the granite.

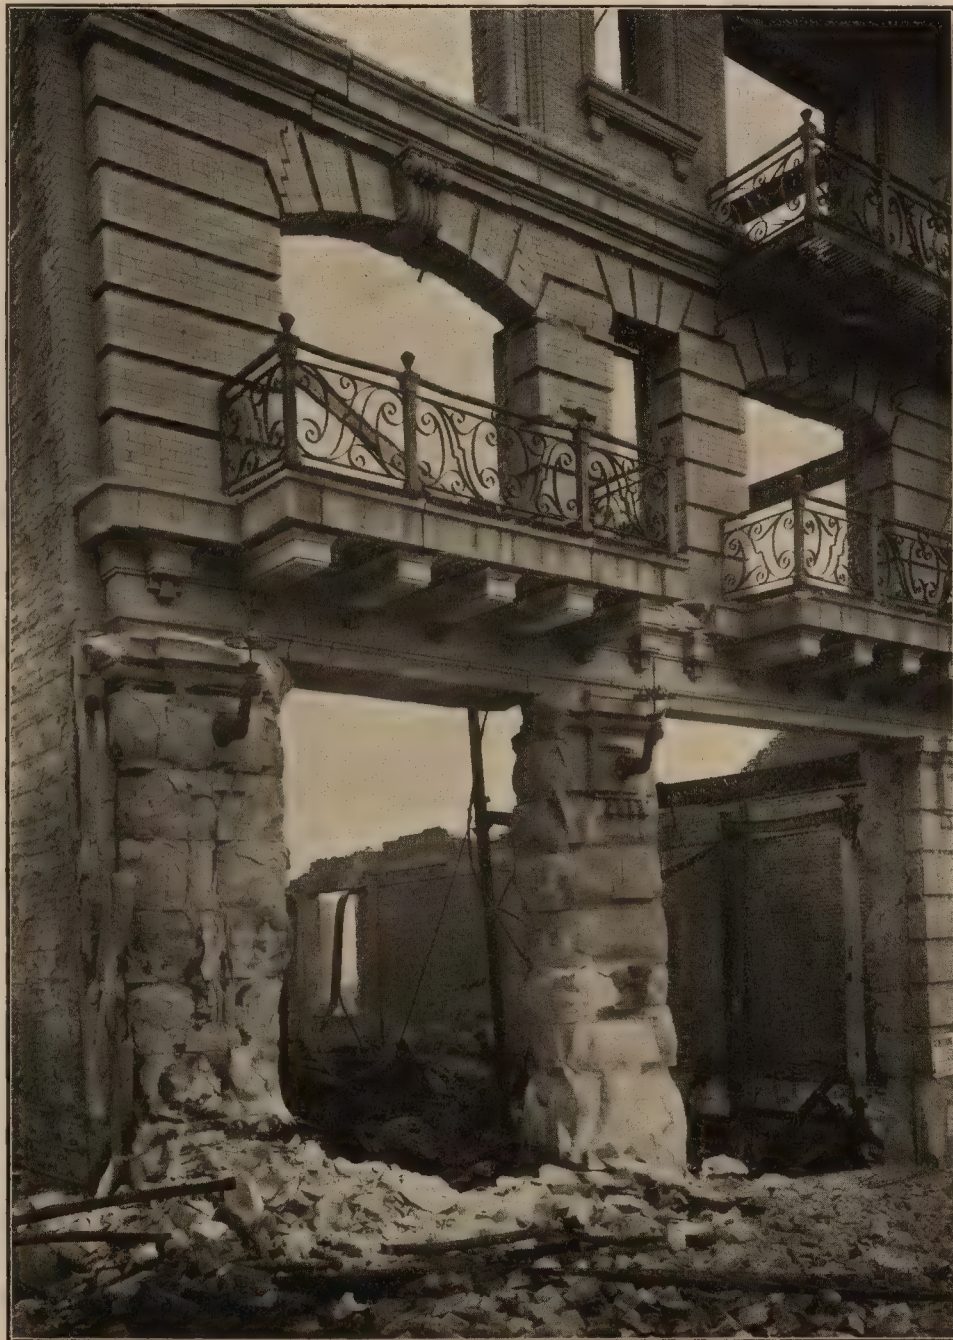
*San Marco Apartments*

Brick and terra cotta versus granite. Compare action of fire.

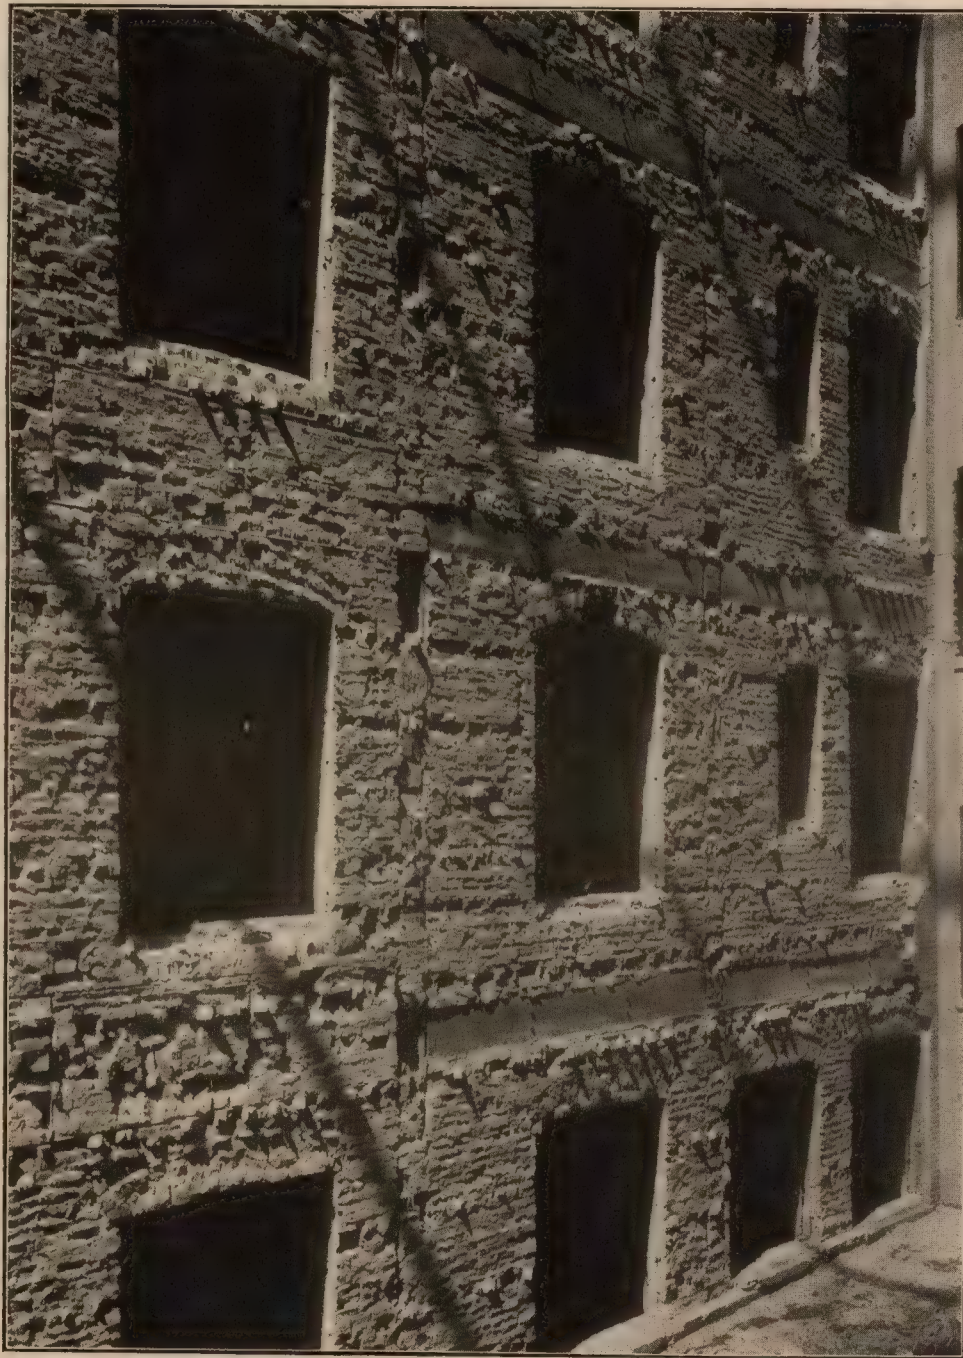
*Light Court, St. Francis Hotel*

Poorly constructed brickwork.

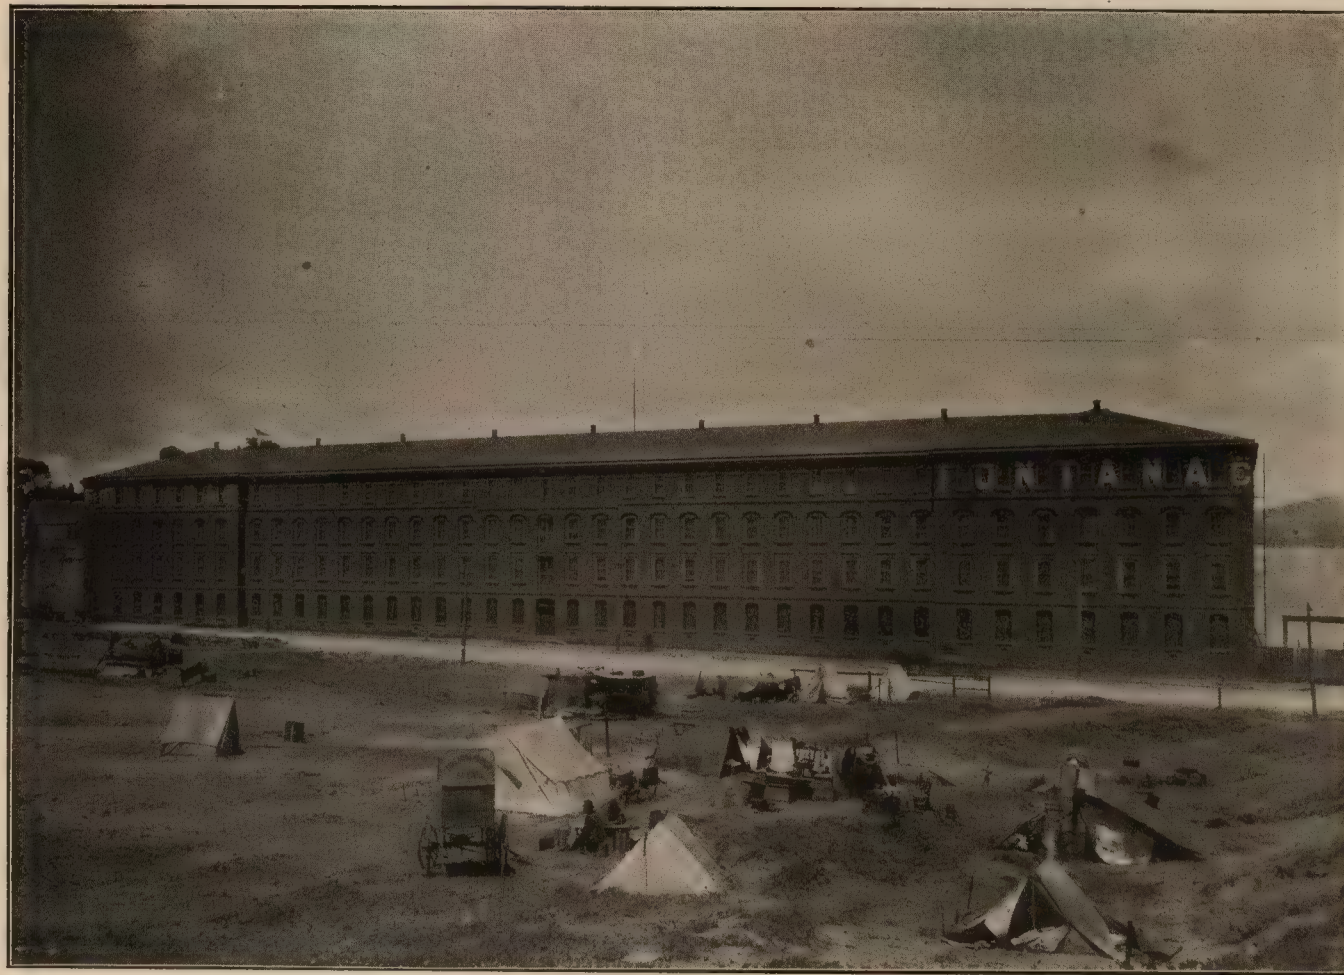
*Fontana Warehouse*

Near the Presidio, taken after the earthquake. A picture that speaks for itself.  
Refugees' camp in the foreground.

Attention is called to the roof construction. Practically no damage was done to  
any brick building in San Francisco having this hip roof construction.

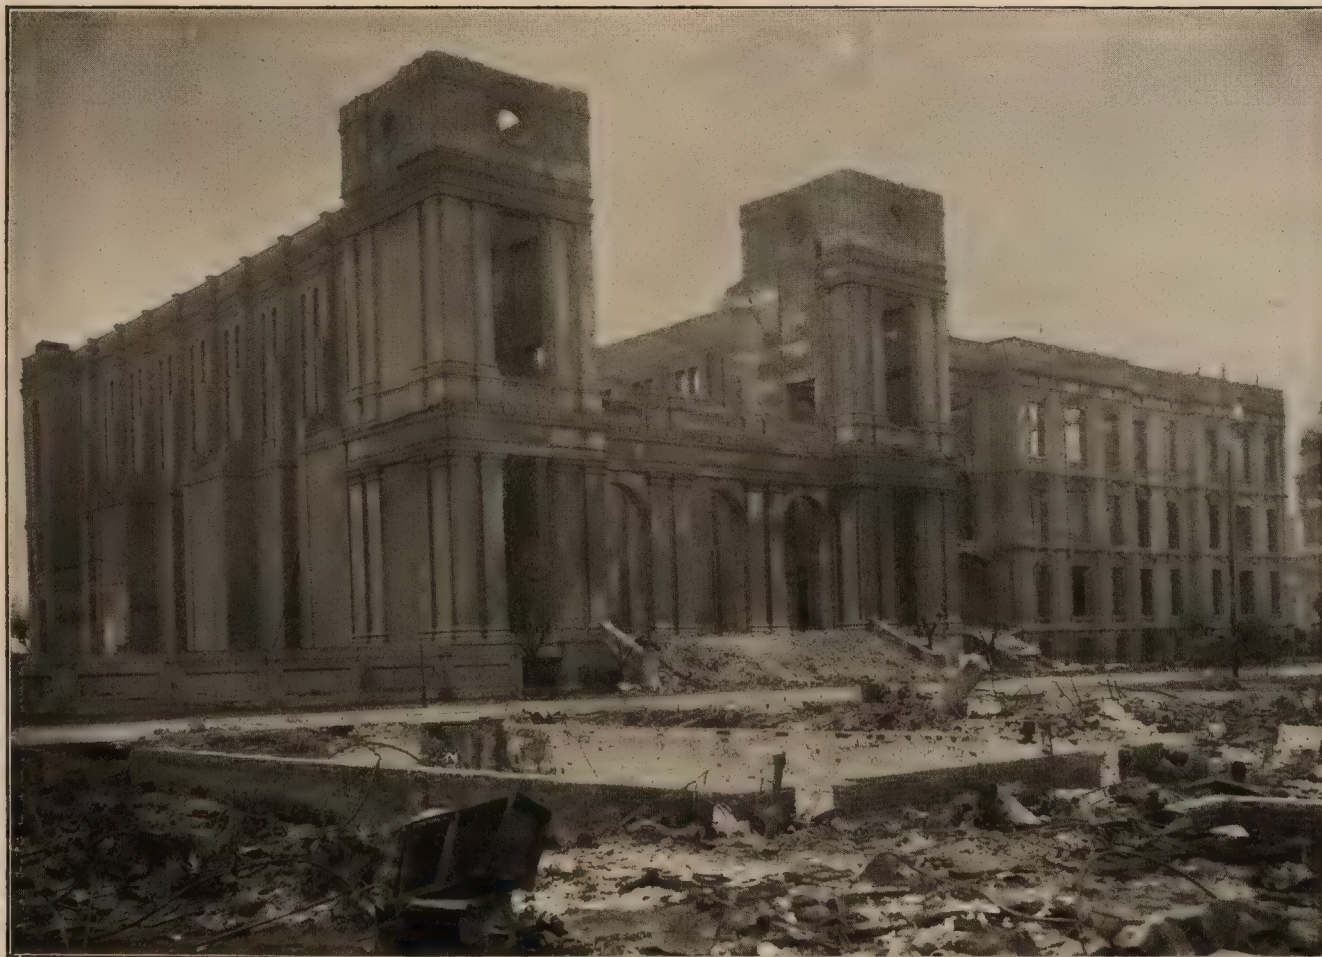
### *The City Hall*

This building cost millions of money, and was undoubtedly the plaything of grafters. Even in the parts not burned the concrete is so poor you can kick it out of place; and where fire touched it at all, all life is extinct and you can shake an entire section by walking across it. . . . Here and there are slight evidences of good workmanship; one might almost call them spasms of virtue in careful superintendence. Where the brickwork was well bonded and good cement mortar used, it held so well that though thrown out of place or carried out by the wreckage there are great chunks here and there, four-foot and five-foot cubes, as homogeneous and solid as any rock.

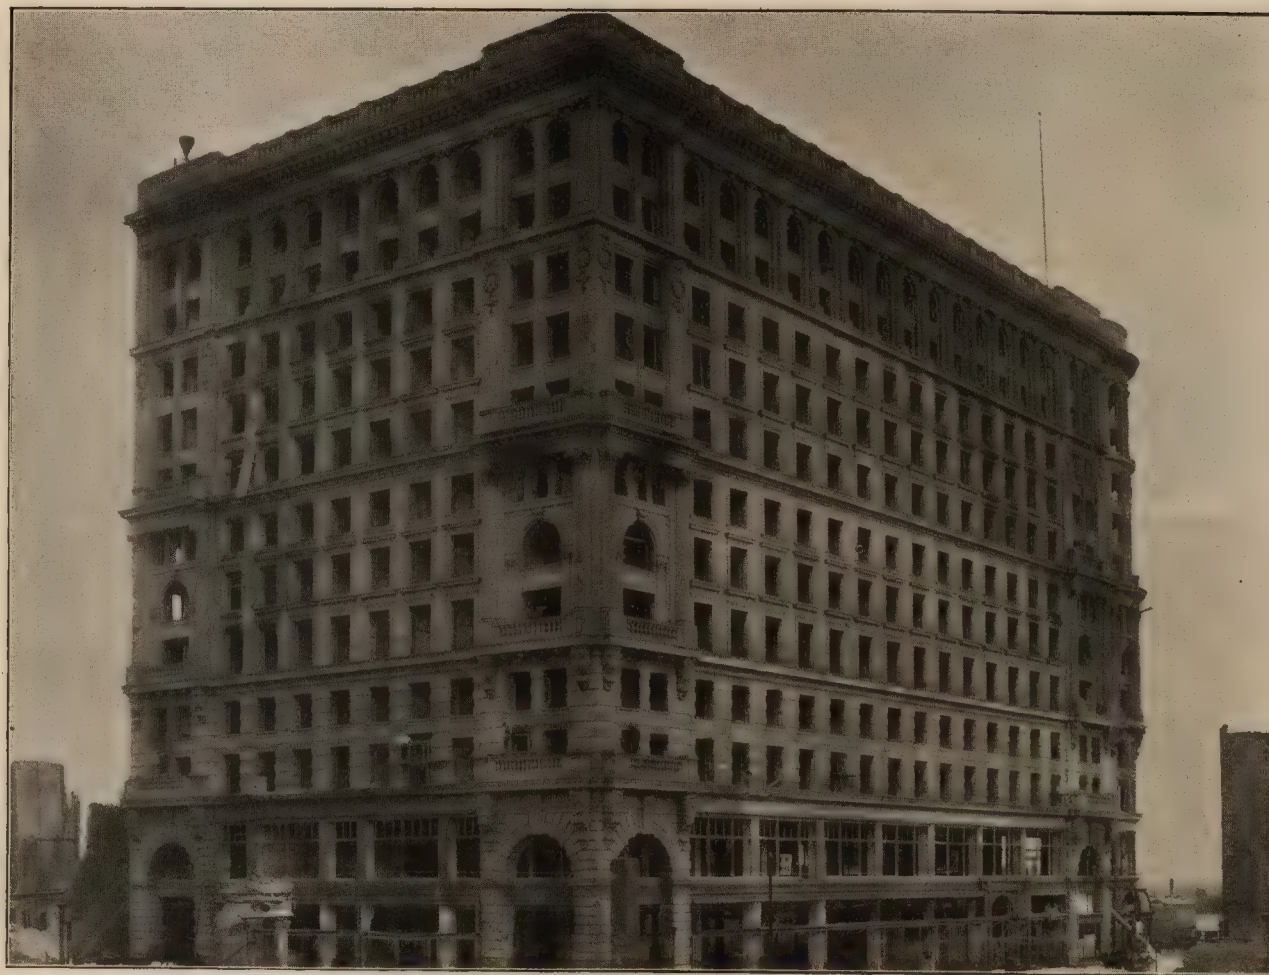
*Flood Building*

Steel Frame. Condition after fire and earthquake.

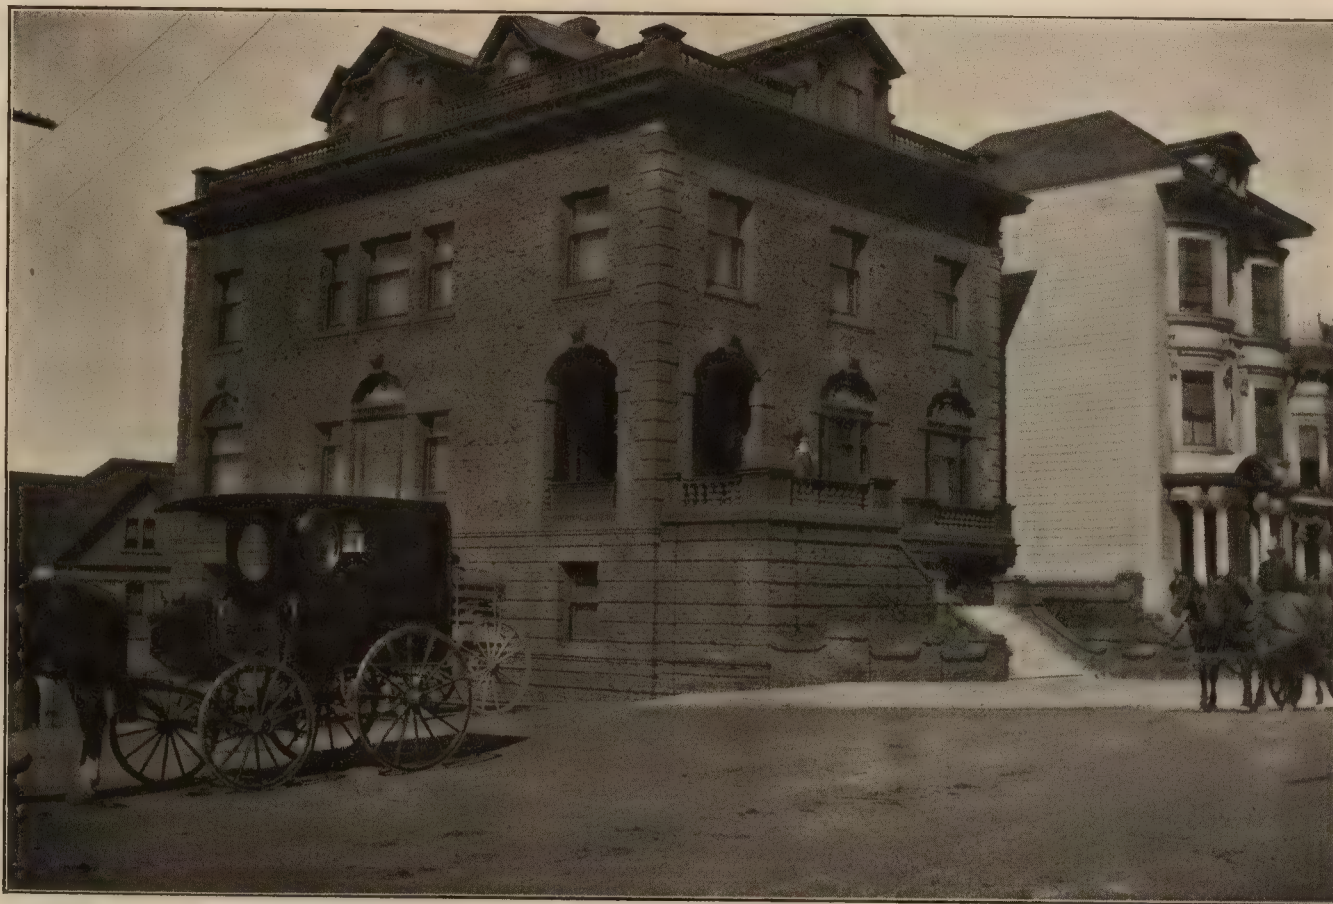
*Brick Residence in San Francisco  
after the Earthquake and Fire*

Not a dollar's worth of damage was done to brick walls.

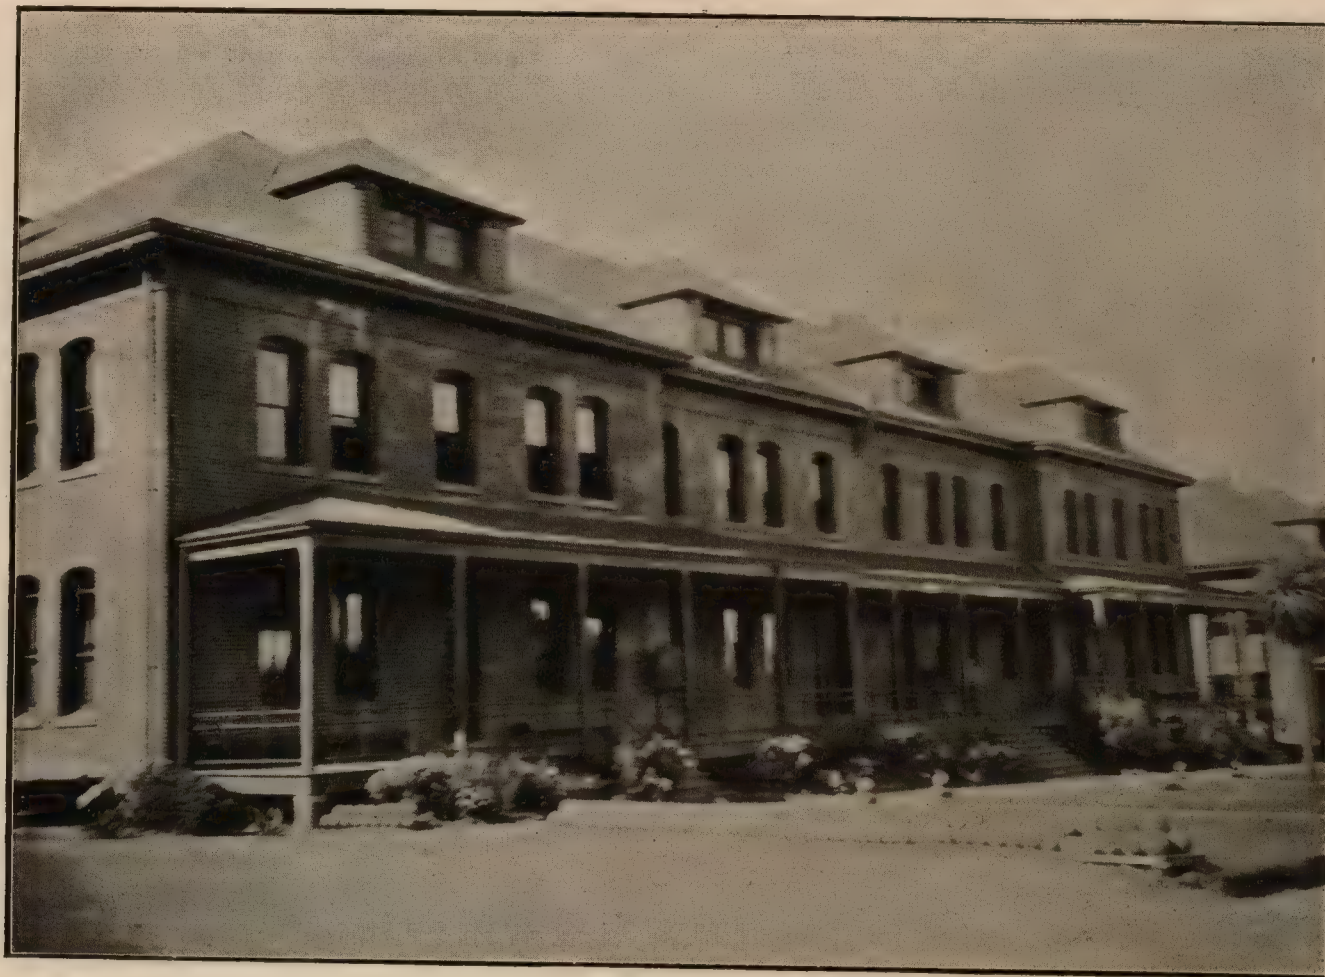
*Presidio*

The brick barracks of the government buildings were uninjured by the quake, although at this point it was most severe. Note hip roof. Buildings of this class with a hip roof generally escaped without damage.

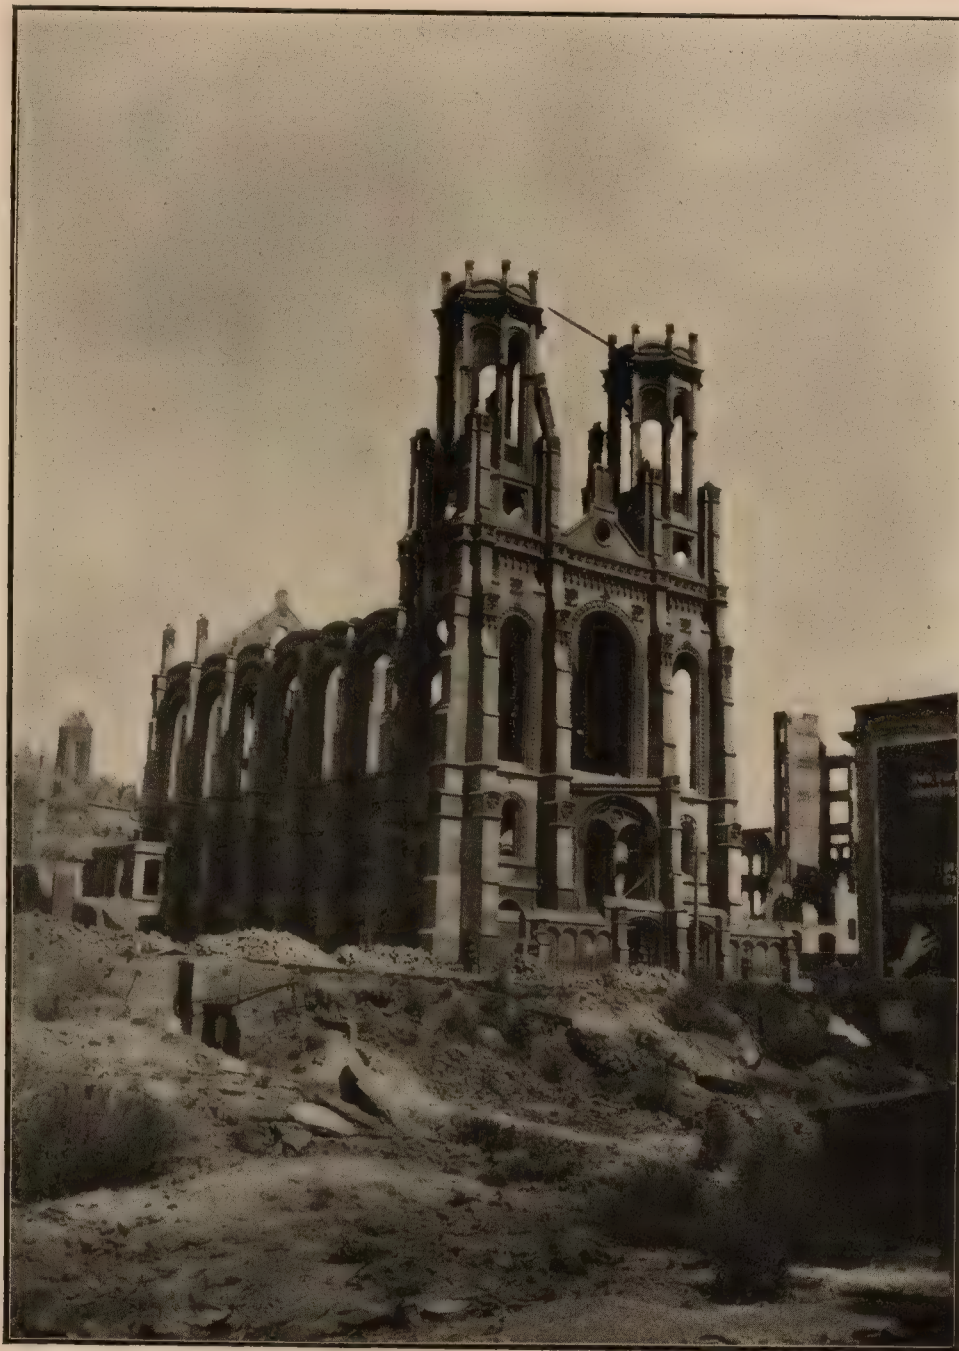
*Temple Emanu-El*

Honest brick work and competent designers.

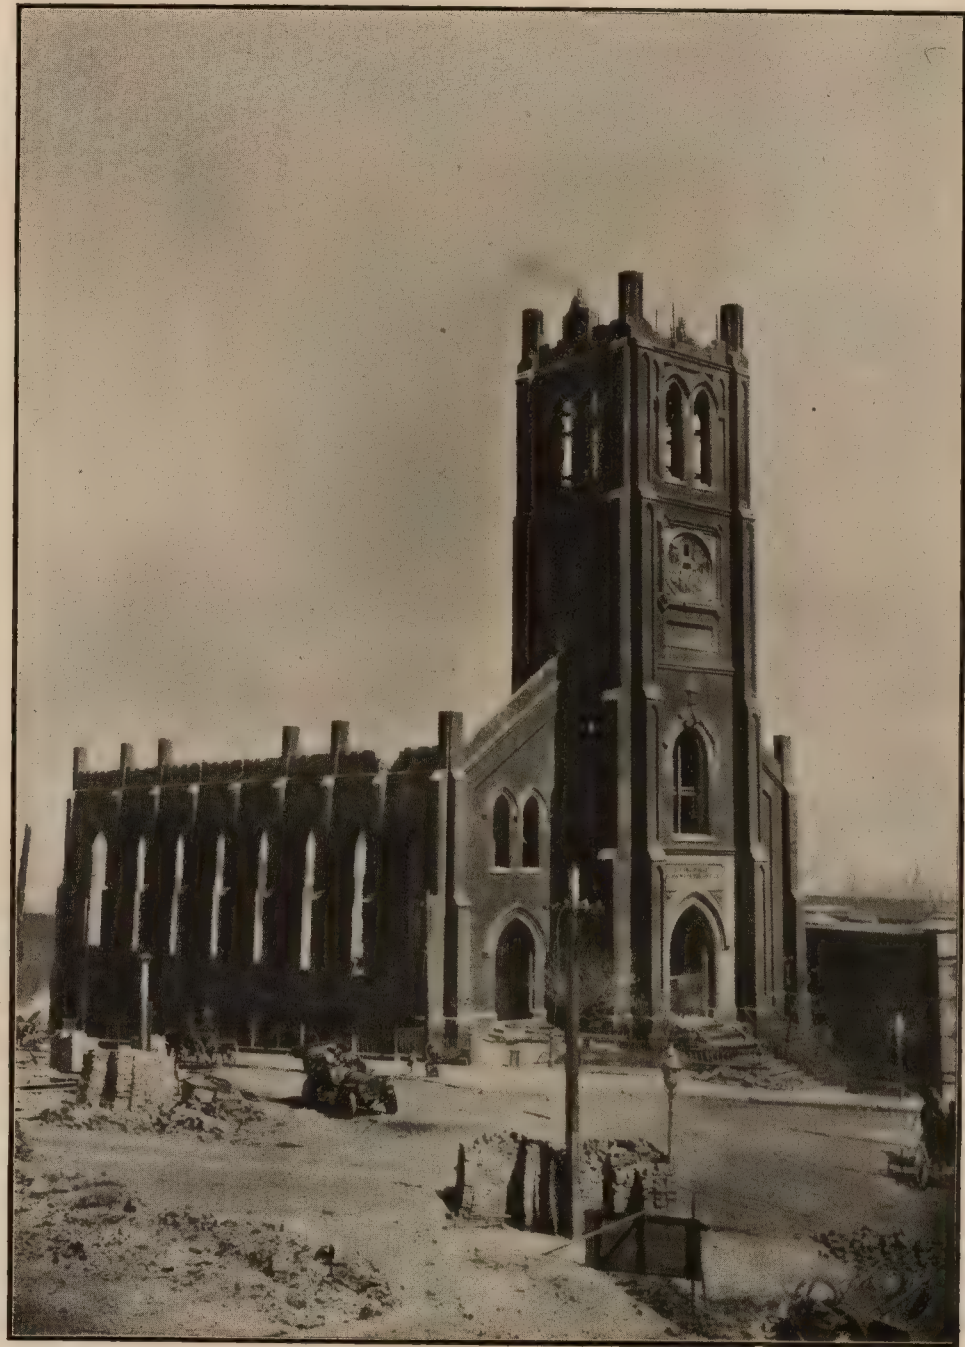
*St. Mary's Church, Erected 1854*

This building has suffered two earthquakes and two fires. Note substantial manner of construction, which shows honest brickwork.

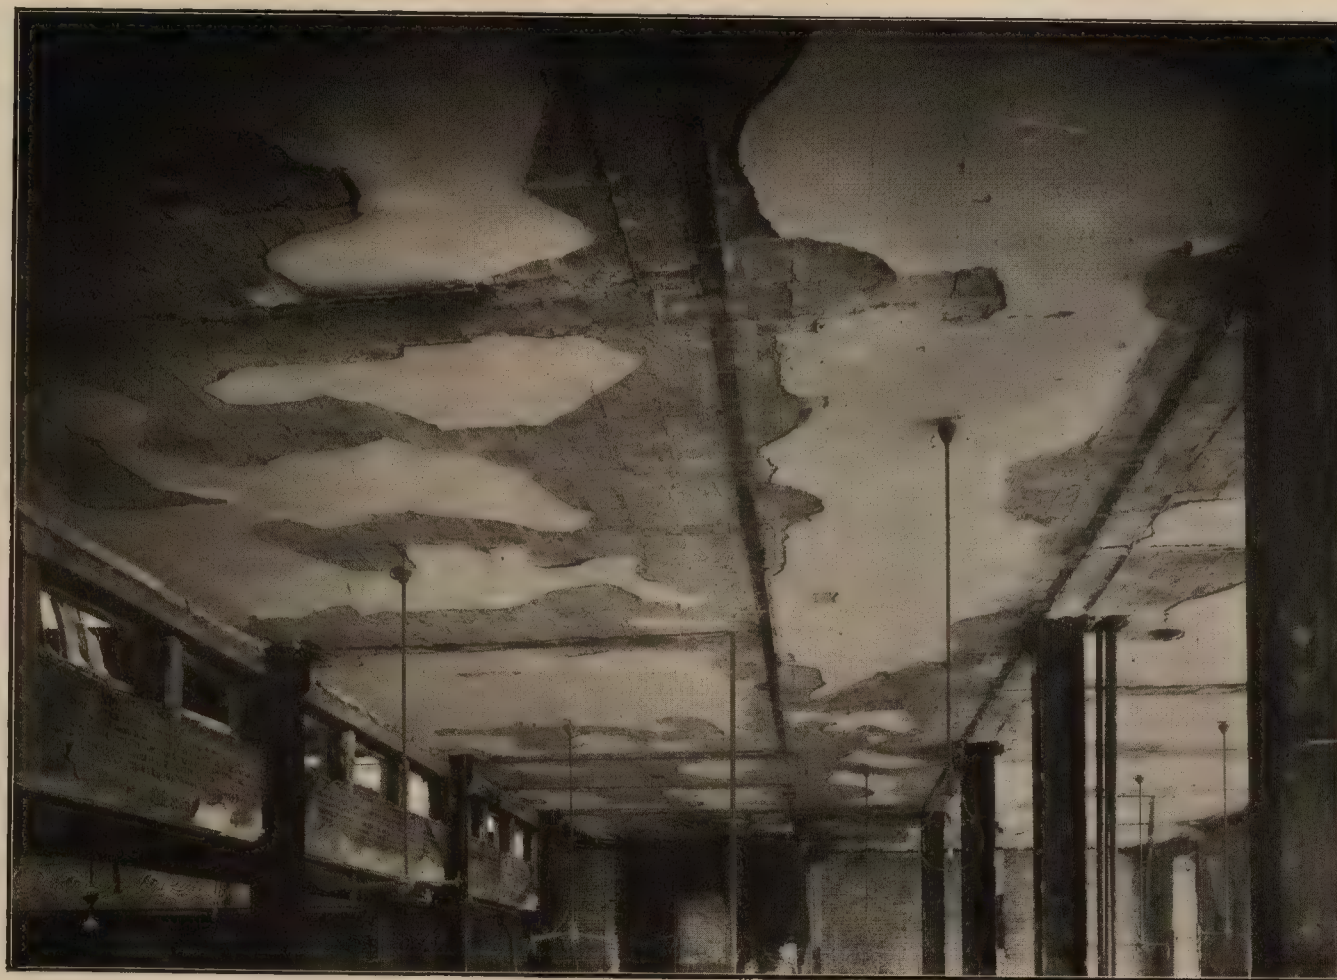
*Mills Building—Steel Frame*

Showing the excellent condition of the tile floors after the fire and quake.

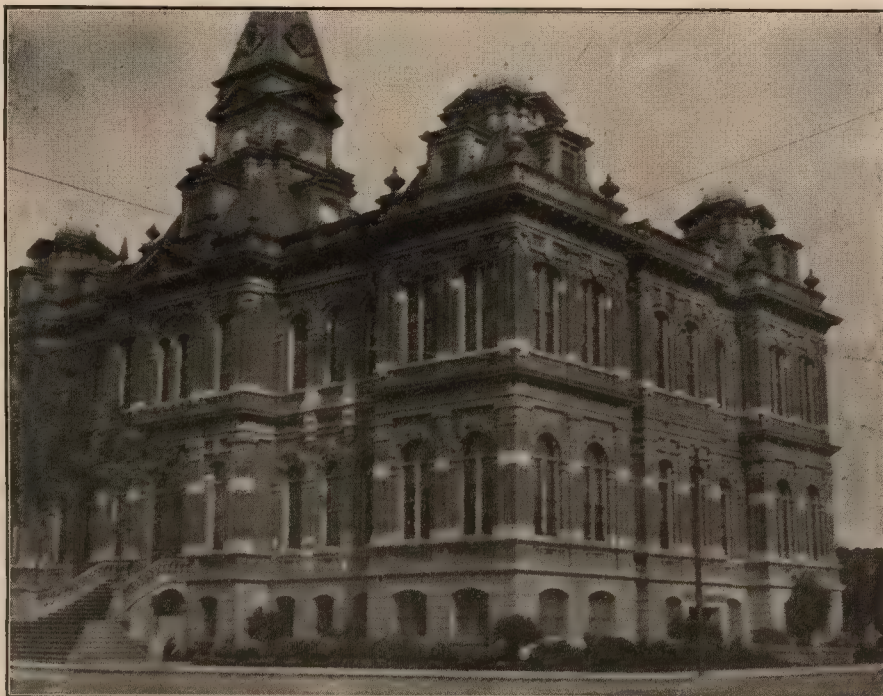
### *Public Building, San Jose*

Old style brick construction. Though the earthquake shock was extremely severe, all of this class of brick buildings were practically unharmed.

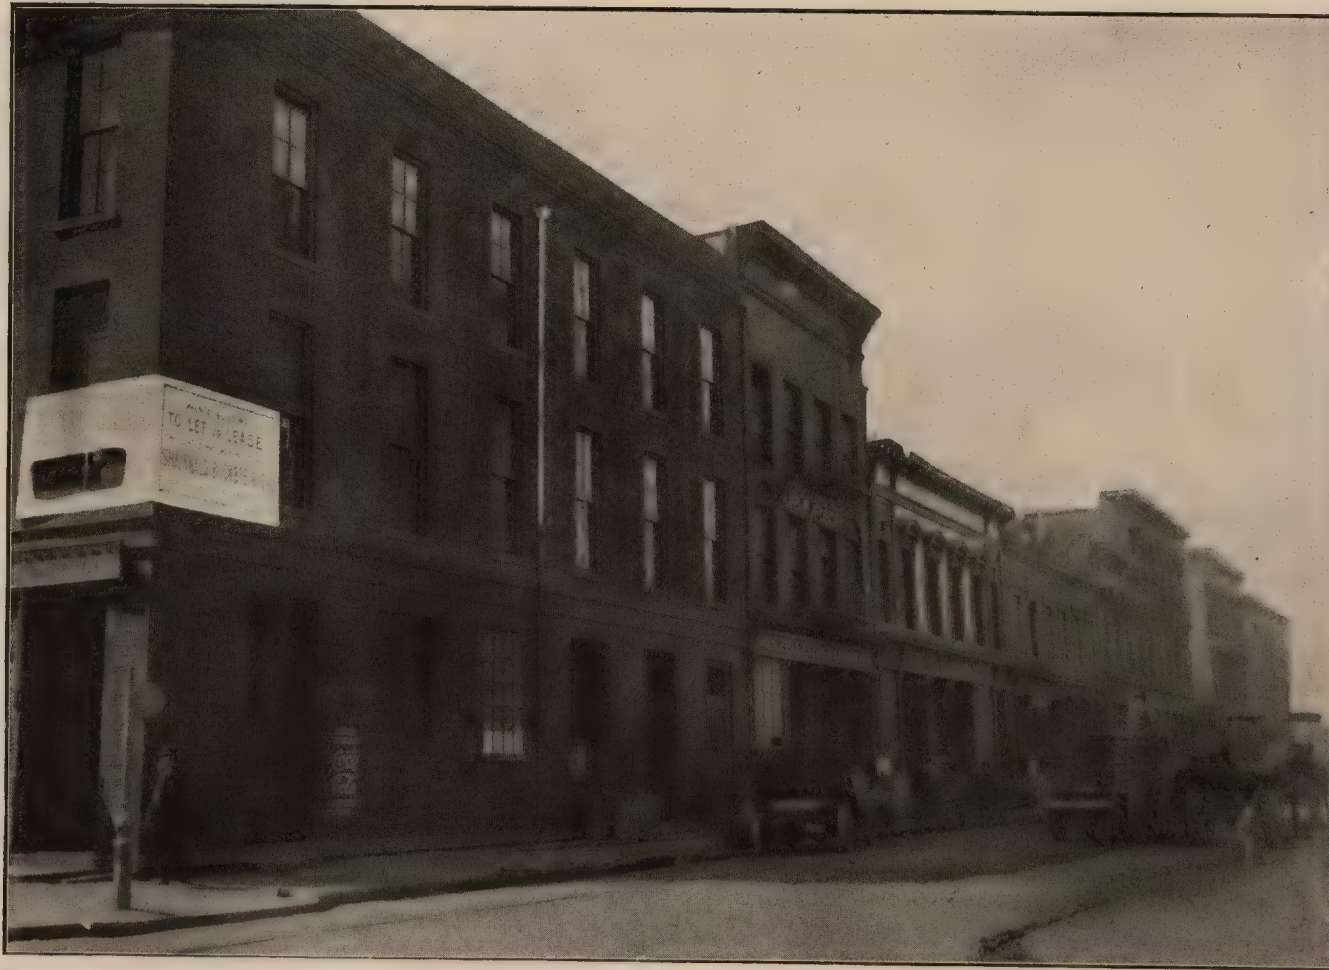
*Southwest Corner Jackson and Sansome Streets*

This row of brick buildings on the southwest corner of Jackson and Sansome streets, was erected in the early sixties. Old style construction, with good, heavy brick partitions, which held in time of need. The vibrations at this point were very severe, but good brick construction withstood them.
